# Inspection Report

1335 Pulaski Rd.  
East Northport NY

**North Shore Home Inspection Service**

<b>Date:</b> 8/6/2012	<b>Time:</b> 10:00 AM	<b>Report ID:</b> 1221
<b>Property:</b> 1335 Pulaski Rd. East Northport NY	<b>Customer:</b> Meagan Walsh	<b>Real Estate Professional:</b> Lisa Collet

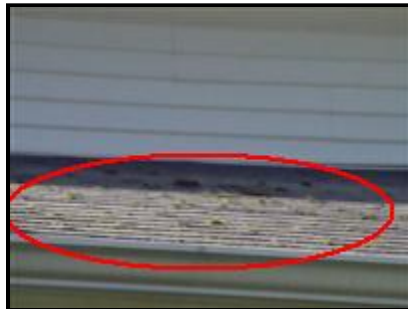
**1.0** According to the Real Estate Agent, the roof covering is 10 years old. The rear,(north side) has some existing moss growing. Moss holds moisture and can shorten the life expectancy of the roof covering.I recommend a professional roof specialist for a thorough cleaning of the moss.Some companies are also knowledgable in removing stains.

1.0 Picture 1 Moss growing on rear roof shingles

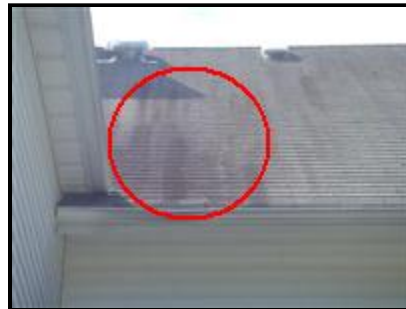
1.0 Picture 2 Rear roof stains,which can be professionally removed

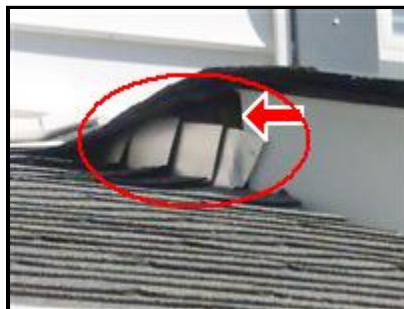
**1.1** There is one area in the front that does not appear to have proper flashing or trim.I Recommend a professional contractor for repairs.

1.1 Picture 1 Front part of roof fascia needs proper flashing repair

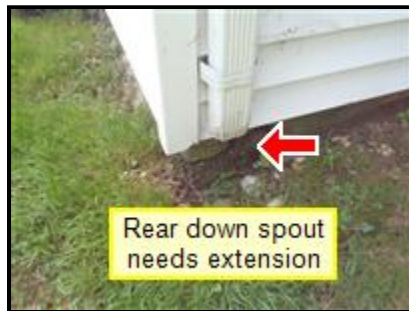
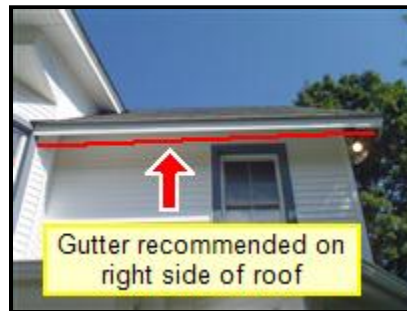
**1.3** The gutters appear intact but due to the lack of rain at the time of inspection, I am unable to determine if gutters leak at seams or spills water. There is no gutter on the top right side of the roof. A gutter is recommended.

The rear down spout needs an extension to drain water away from the home.

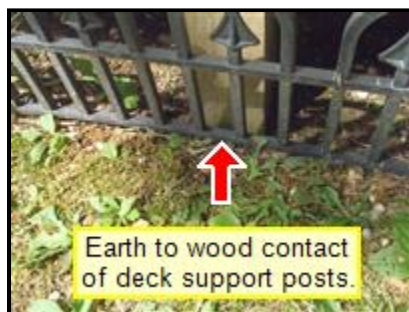
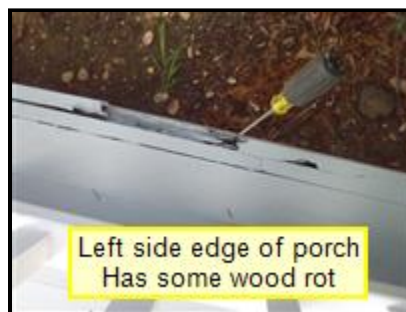
**📍 2.3** Although there appears to be proper concrete footings for the deck support posts, there is wood to earth contact. Wood to earth contact can eventually rot the support posts. Removal of soil from the base of the support posts is recommended.

The left side of the front porch has some wood rot. Minor repair is recommended.

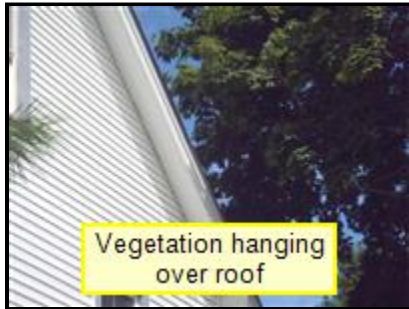
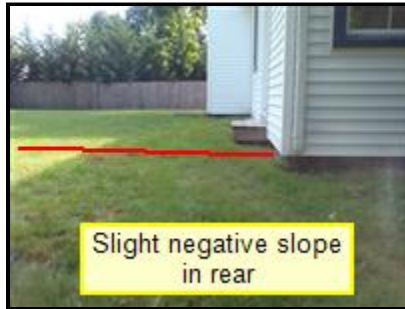
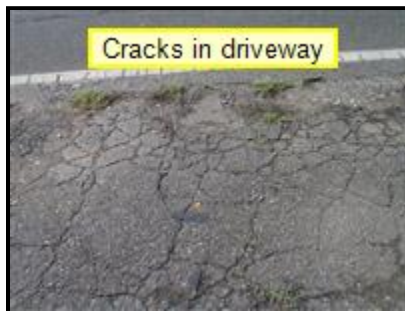
**2.4** There is some vegetation hanging over the roof. Vegetation hanging over the roof should be trimmed away.

There is a negative slope at the rear of home and can cause or contribute to water intrusion or deterioration. I recommend correcting landscape to drain water away from home.

. The driveway has many normal settling cracks, Remaining life expectancy cannot be determined.

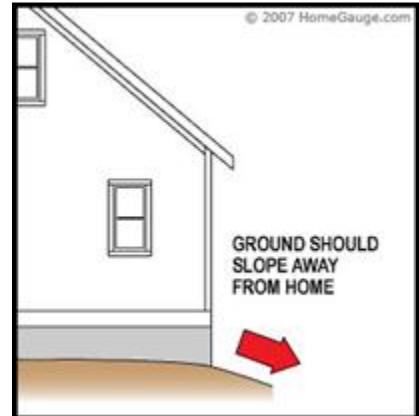
2.4 Picture 3 Ground should slope away from home, 1" per foot for at least 6 feet

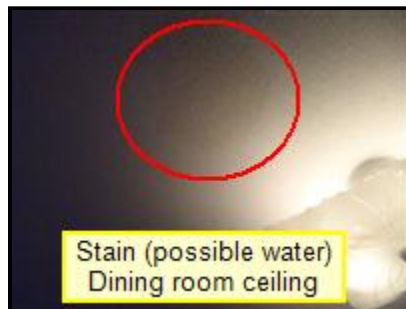
4.0 Picture 1

**4.0** There is one stain on the dining room ceiling which I could not identify the source or cause. Monitoring is suggested.

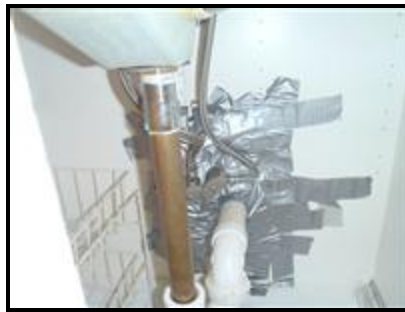
**4.1** The 2nd floor bath has a large hole under the sink and should have a professional repair.

4.1 Picture 1 Large hole under sink vanity with duct tape

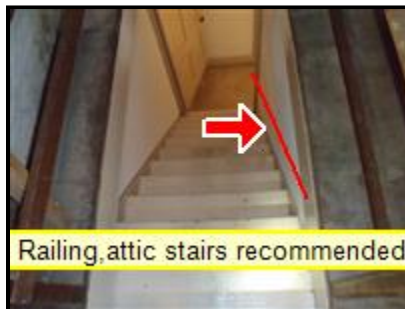
4.3 Picture 1

**4.3** Stairs to the attic is missing a hand rail. A hand rail installation is recommended. This is considered a safety hazard.

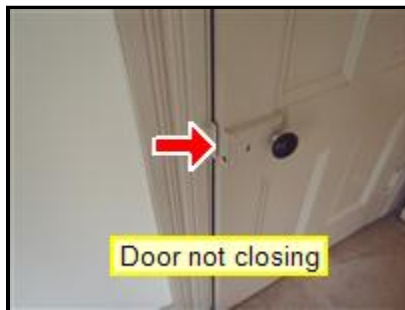
4.5 Picture 1

**4.5** There is one closet door on the second floor that is not closing properly and needs adjustment.

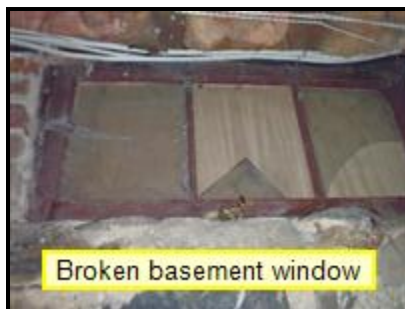
4.6 Picture 1

**4.6** One basement window is broken and is boarded up. Repairs recommended.

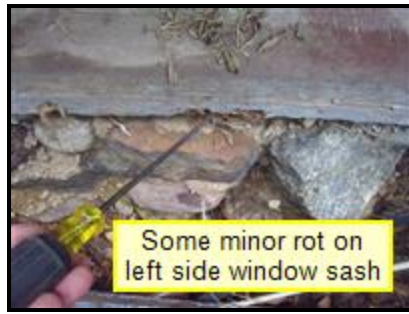
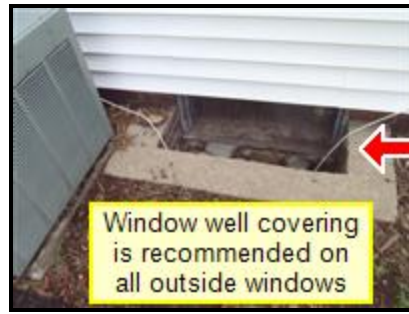
**5.0** The basement foundation consists of stone and there is some dampness and possible minor water intrusion. Proper outside grading, covering of window wells, and the installation of down spout extensions is recommended.

The left basement window wood sash is slightly rotted. Repair is recommended.

The crawl space floor is all dirt which contributes to moisture. Sometimes plastic vapor barriers are installed over the dirt to help prevent the natural build up of moisture. I recommend consulting with a professional water proofing company for advice and possible installation of a vapor barrier in the crawl space. This is not a necessity, but is highly recommended. There also should be some venting, and I did not notice any outside vents for the crawl space.

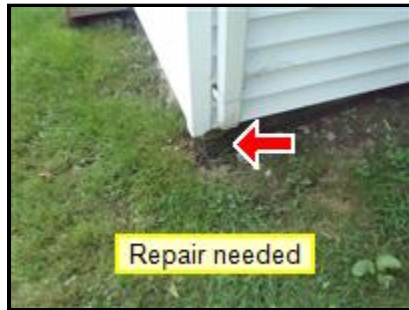
5.1 Picture 1

**5.1** Recommend repairs to foundation wall in left rear corner of home. I noticed some minor rot on the sill leading to the basement. It does not appear to be termite damage.

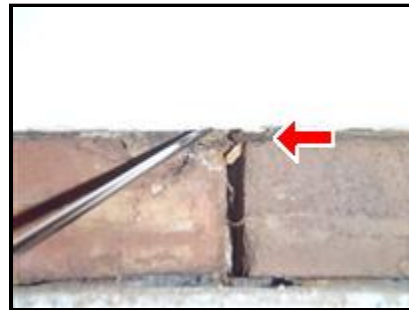
5.1 Picture 2 Minor wood rot area leading to basement

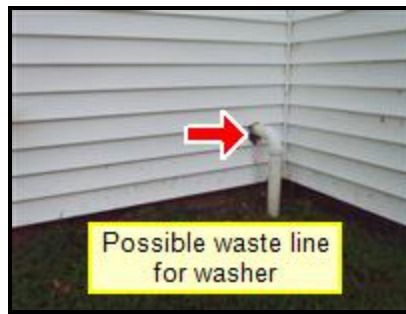
6.0 Picture 1

**6.0** The washer may possibly be draining into a drywell. Monitoring is suggested and possible periodic maintenance may be needed.

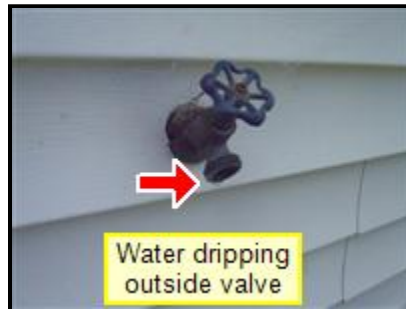
6.1 Picture 1

**6.1** The rear outside water valve is leaking. Recommend a qualified plumber for repairs.

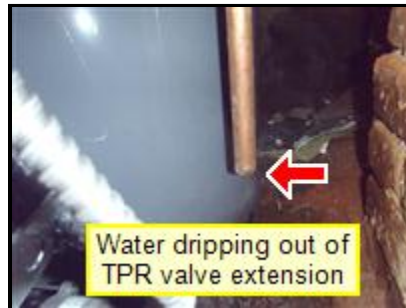
6.2 Picture 1

**6.2** The TPR valve on the hot water heater is pushing out water and should be checked by a qualified plumber.

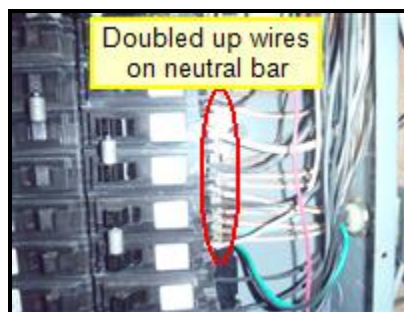
7.1 Picture 1

**7.1** There are some doubled up wires on the neutral bus bar in the main panel. Although this is not to code, if the same gage wires are doubled up under the same lug, I do not feel this is a hazard, even though it is not to code. Recommend an evaluation by a licensed electrician.

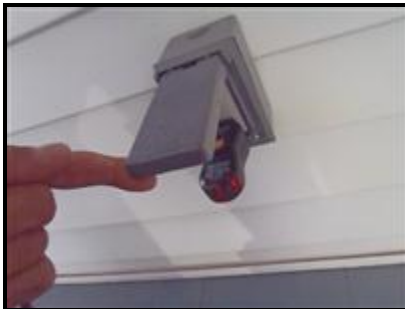
- The front porch GFI outlet did not trip when tested.
- Loose outlet in one room.
- Open wires should be in junction boxes or be removed.(Basement)
- Missing smoke detector in basement.
- Panel box, All circuits should be labeled.
- Loose round box in basement.

7.4 Picture 1 Front porch GFI was on but did not trip when tested

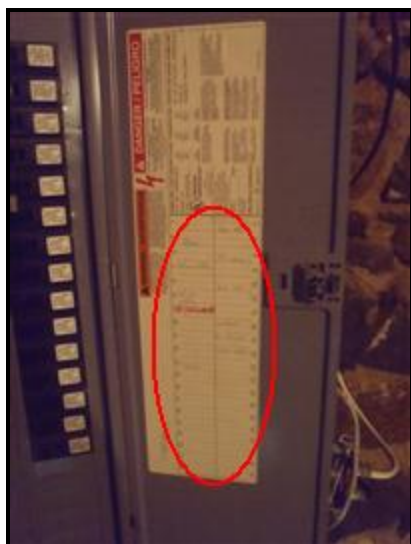
7.4 Picture 7 Not all circuits are labeled

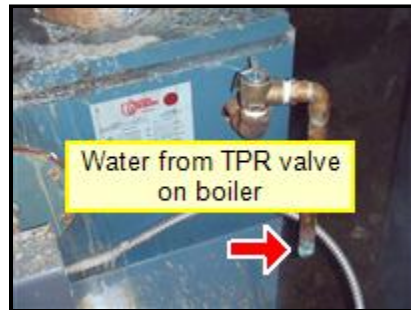
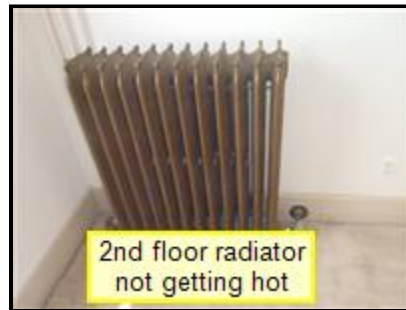
**8.0** The heating system in the house was once steam and converted to a circulating boiler. According to the serial number, The boiler was manufactured in August of 1998. There is no rule of thumb for determining the average life span of an oil burner. I have seen them last up to 50 years or more.

When the boiler was shut off by the emergency switch, the TPR valve let go, pushing out water and the temperature gage was reading 190 degrees. I recommend a qualified heating contractor for repairs.

One of the radiators on the 2nd floor did not seem to get hot when testing the heating system. The valve could possibly be turned off. Recommend heating or plumbing contractor for an evaluation.

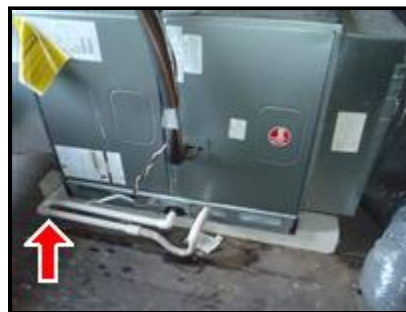
**8.5** The condensate lines for the air handler are teed together and is leaking. The condensate lines can be teed together as long as there is a float switch in the drain pan. I did not notice a float switch. Correction is needed.

8.5 Picture 1 Condensate lines are teed together and is leaking

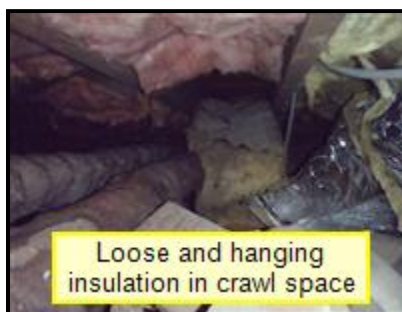
9.1 Picture 1

9.1 Some insulation is hanging in the crawl space and should be re installed.

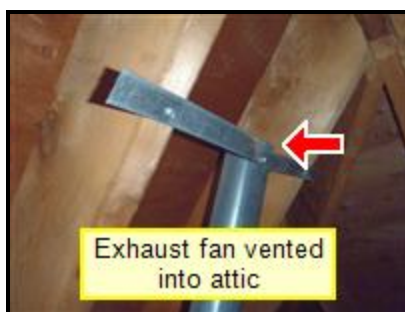
**9.4 Picture 1**

9.4 The 2nd floor bath exhaust fan is vented into the attic.Bath exhaust fans should be vented to the outside.Proper venting is recommended.
