Inspection Report

29 Spruce Street
Valley Stream NY

Date: 11/20/2013	Time: 01:30 PM	Report ID: 1095
Property: 29 Spruce Street Valley Stream NY	Customer: Sophia & Sulman Beg	Real Estate Professional:

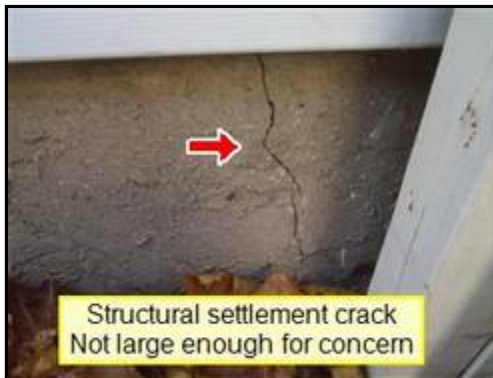
1.1 Picture 1

1.1 There are a few of structural settlement cracks noted on the exterior, but are not large enough for concern.

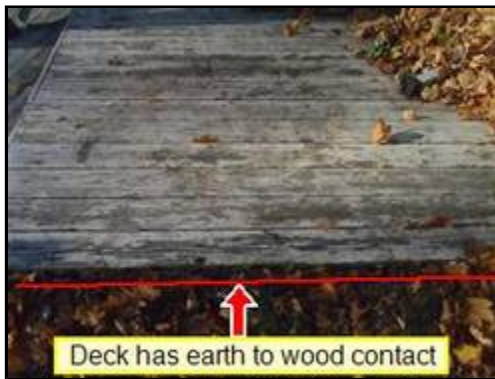
1.2 Picture 1

1.2 The rear deck is too low to the ground (earth to wood contact) and there may wood rotting at edges and the underside of the wood, which is not visible. The deck needs cleaning with a "Deck wash" and sealed with a waterproof sealant.

The front hand rail is loose. Proper repairs to secure the hand rail are needed for safety.

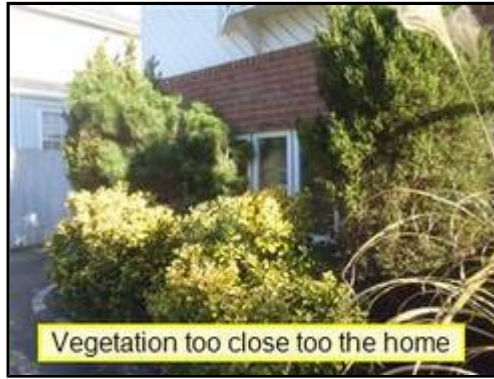
1.5 Picture 1

1.5 There is some vegetation close to the home. Vegetation too close to the structure can invite moisture and insects into the home. Removal or trimming is recommended.

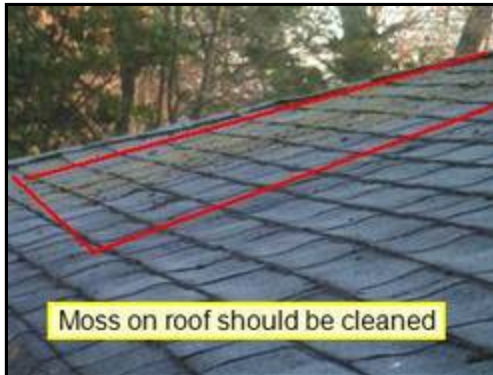
2.0 Picture 1

2.0 The roof covering is a architectural roof and life expectancy for this type of roof is usually about 30 years. It is very difficult to determine the age and remaining life expectancy, but it appears to have at least several years or more of life remaining. This is my personal opinion. It is beyond the scope of a Home Inspector to determine the life expectancy of any item. The roof covering appears to have 2 layers.

The rear roof has some moss. Moss holds moisture and can shorten the life expectancy of the shingles. Removal is recommended. Tree limbs hanging over roof should be trimmed.

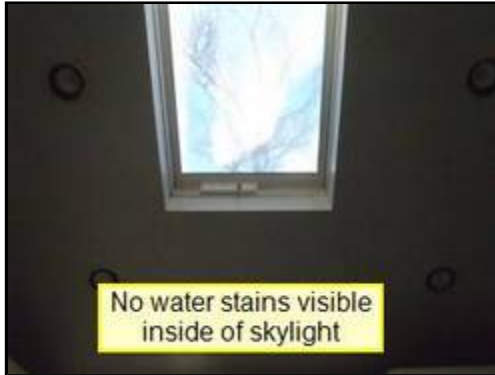
2.2 Picture 1

2.2 There is one skylight present. Skylights have been known to leak, but I have found no evidence of this at the time of inspection.

A chimney rain cap/spark arrestor is missing and is recommended for the chimney flu.

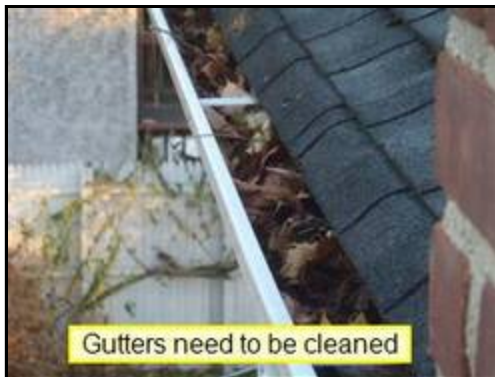
2.3 Picture 1

2.3 The gutters appear intact but, I am unable to determine if gutters leaks at seams or spills water. The gutters are full of debris in areas and needs to be cleaned. The debris in gutters can also conceal rust, deterioration or leaks that are not visible until cleaned, and I am unable to determine if such conditions exist. The downspout needs a repair and an extension or buried drain line to carry water away from the home .

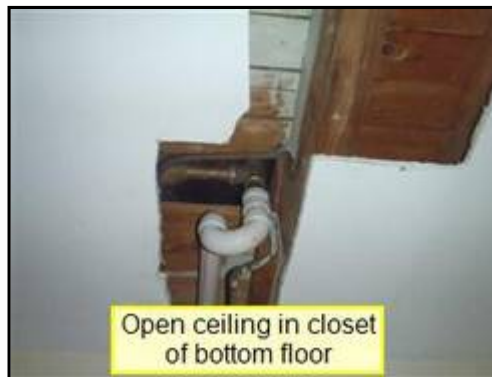
3.0 Picture 1

**3.0** Closet ceiling on bottom floor has a large opening and needs repairs.

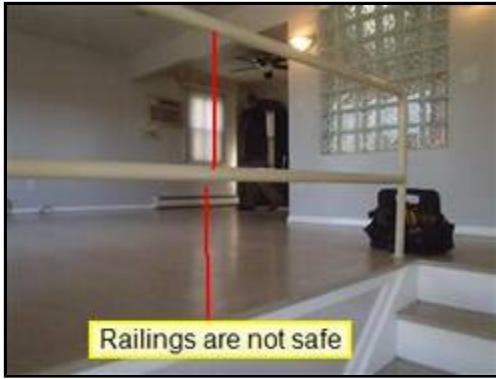
3.3 Picture 1

**3.3** The interior railings have large openings and are climbable. A small child or pet can easily fall through and injury could occur. Proper railings with balusters not spaced more than 4" apart are required for safety.

The pull down stairs to the attic is difficult closing. The side hinge needs repair.

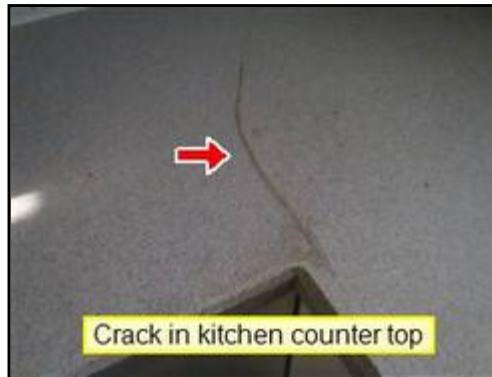
3.4 Picture 1

3.4 The kitchen counter top appears to be corian material and has a long crack on the surface. Repairs recommended.

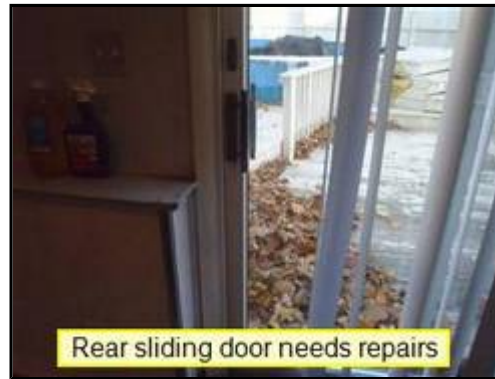
3.5 Picture 1

3.5 The rear sliding insulated door is very difficult to open and close. Repairs are needed.

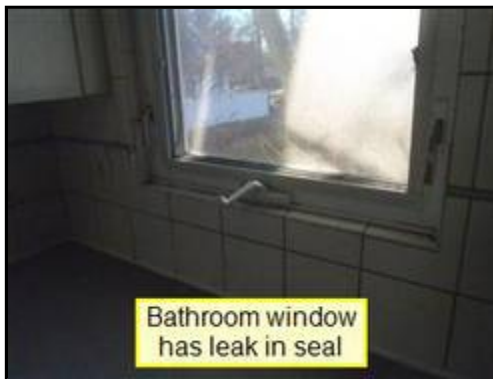
3.6 Picture 1

3.6 There are 3 windows with leaks in the seals and replacement or repairs are needed.

The window crank is broken for the front bay window.

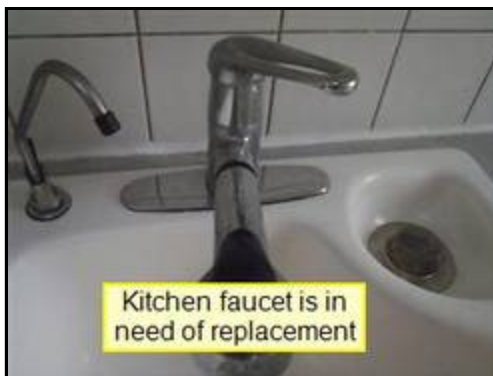
5.0 Picture 1

- The sink faucet in the kitchen does not stay opened when operated. New faucet is needed.
- The slop sink leaks at the base and there is also a leak in the plumbing trap. This must be repaired because the washer drains into the slop sink. A qualified plumber is recommended.

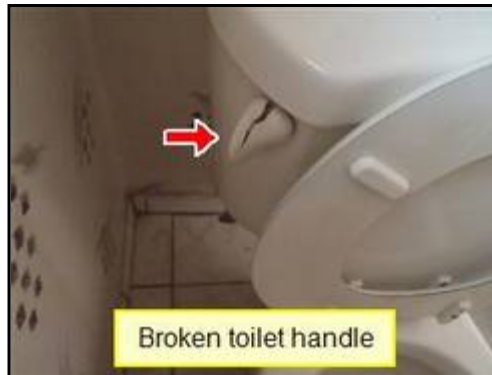
5.1 Picture 1

5.1 The bottom floor toilet has a broken handle and keeps running when flushed.

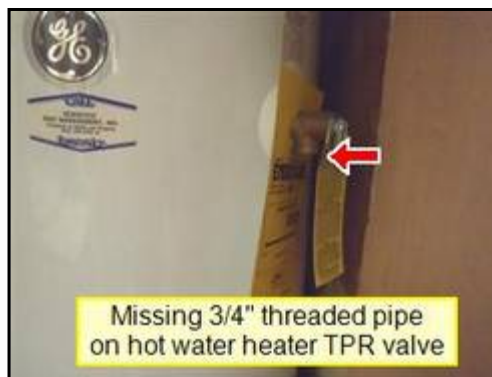
5.2 Picture 1

5.2 According to the ANS on the Hot Water Heater, it was manufactured in 2012. Most Hot Water Heaters have an average life expectancy of 15 -20 years.

The T&P (Test and Pressure) valve on water heater needs a 3/4 threaded pipe to extend within 6 inches of floor for safety. (PVC is not approved for hot water use). I recommend repair by a qualified person.

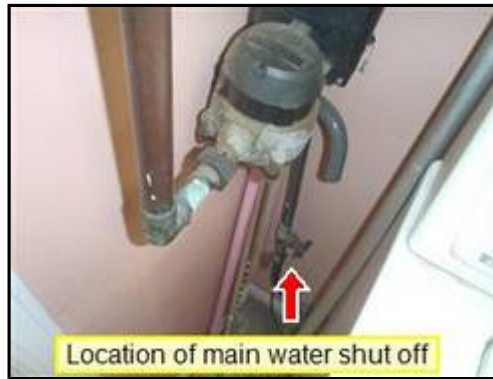
5.3 Picture 1

5.3 The main water shut off is in the laundry room. This information is for the new buyer.

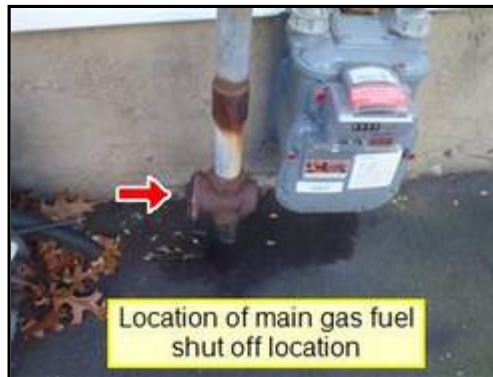
5.5 Picture 1

5.5 The main fuel shut off is at gas meter outside. This information is for the new buyer.

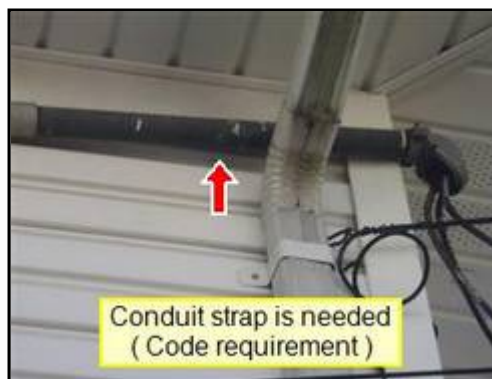
6.0 Picture 1

**6.0** Conduit for electrical service entrance cable is not secured properly and only one strap is holding the conduit to the structure. More straps are required to be secured properly.

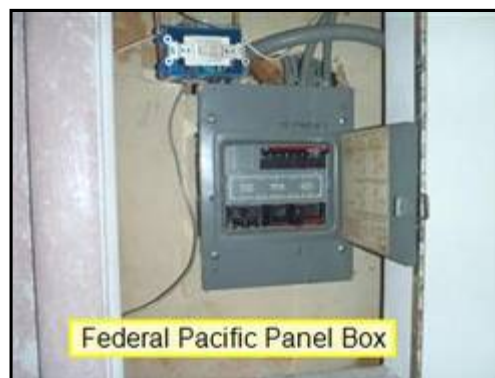
6.2 You have a Federal Pacific panel which was legal at the time of inspection, but there is a possibility that the circuit breakers may not trip when shorted or over loaded, possibly causing an electrical hazard. Federal Pacific did not comply with UL requirements in 1980 and shortly after, Federal Pacific company went out of business. For further information you can check any website under the listing of Federal Pacific. Replacement is a necessity.

6.2 Picture 1 Federal Pacific panel boxes are fire hazards

I recommend you consult a licensed electrical contractor for the replacement.

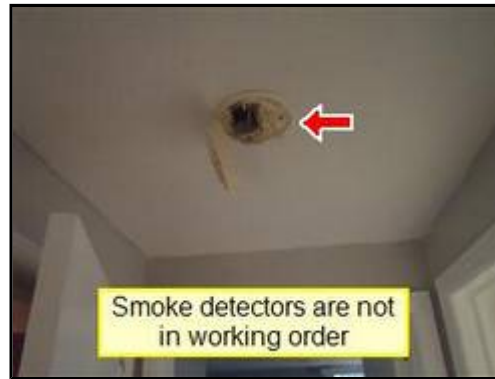
6.4 Picture 1

6.4 There are smoke detectors located in the home and did not work when tested. At least one smoke detector on each floor is necessary, installed to the manufacturer's specifications. Today's electrical codes require one smoke detector in each bedroom and one just outside the bedroom area, in the hallway.

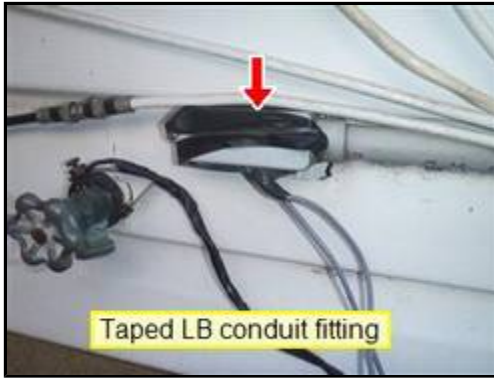
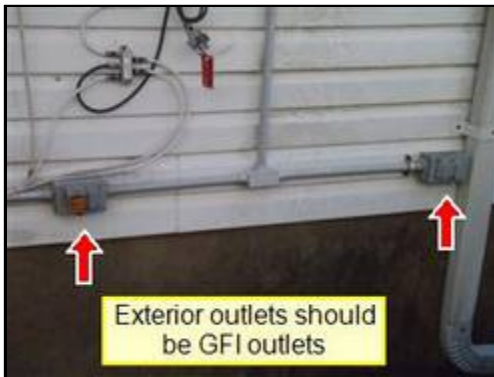
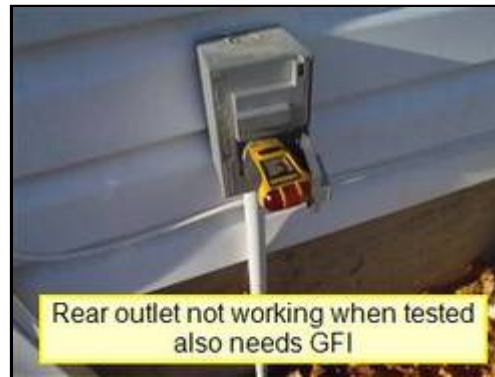
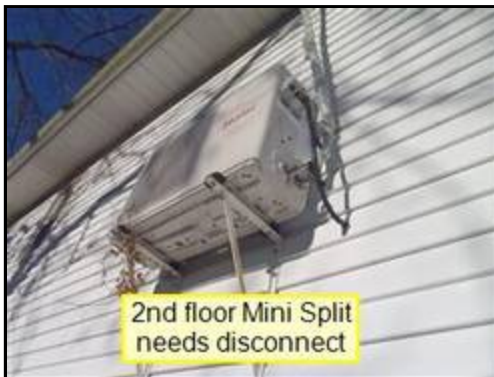
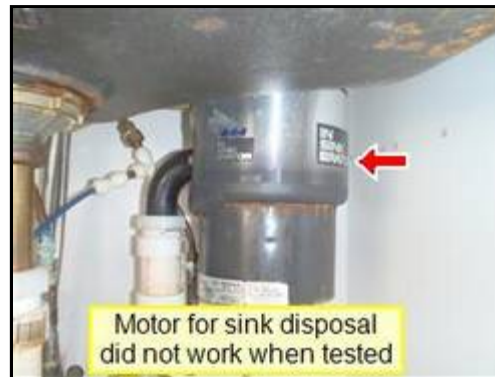
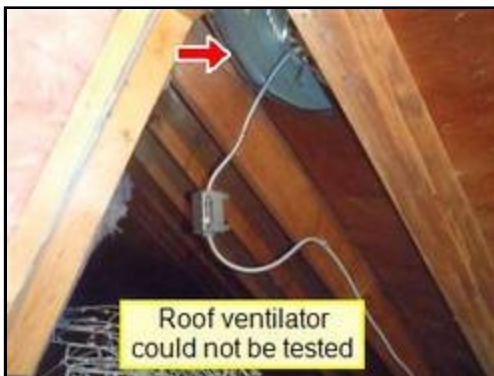
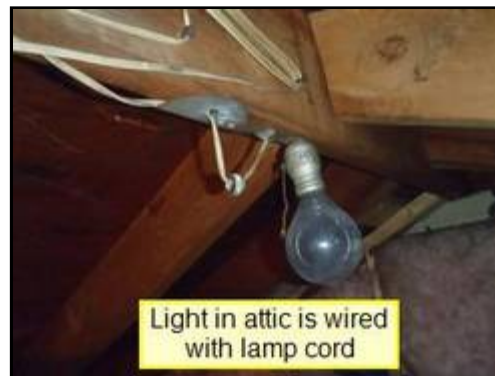
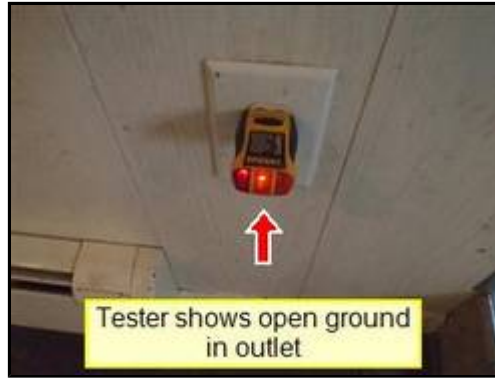
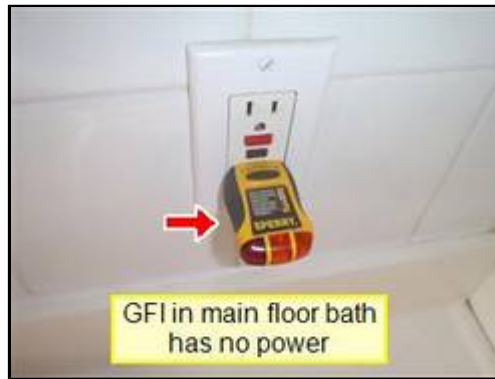
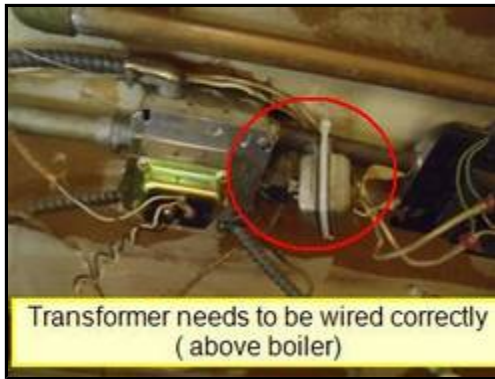
- **Rear lower room has open ground outlets.**
- **The clothes dryer is electric and is hard wired. A disconnect is required by code if the electric panel box is not within site of the dryer.**

- **Transformer above boiler is not wired correctly.**
- **Outlet next to slop sink should be GFI.**

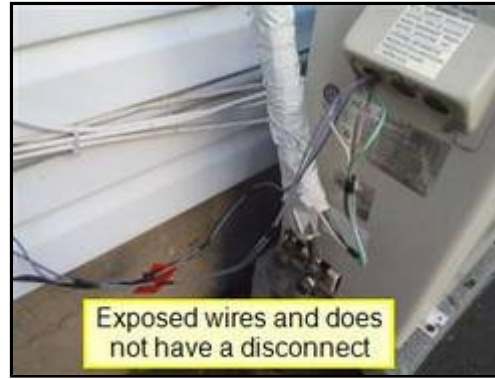
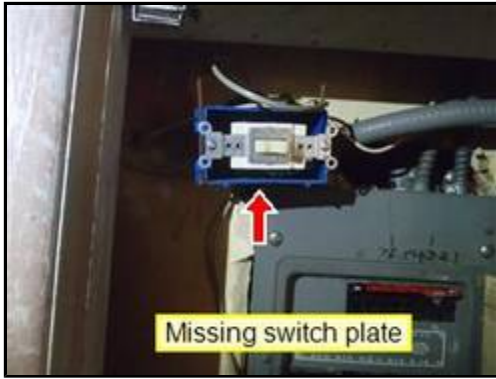
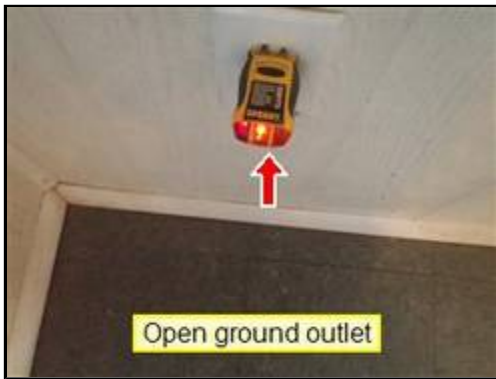
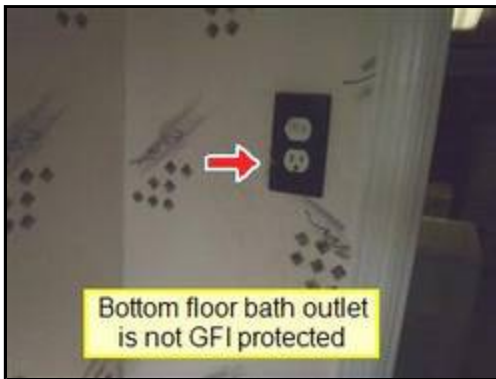
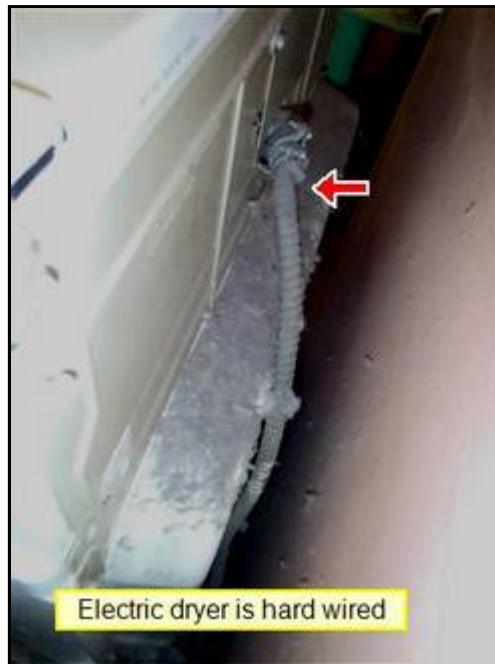
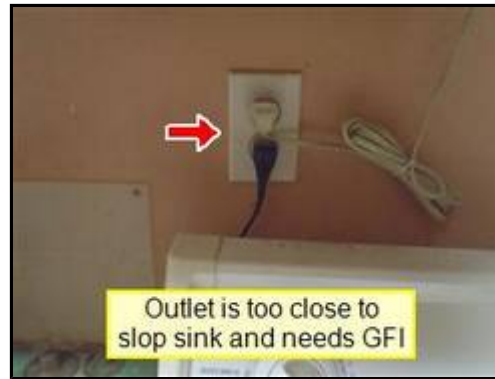
- **Recommend all exterior outlets be changed to GFI outlets.**
- **Rear exterior outlet does not have proper wiring, Hot is reversed and no neutral present. GFI outlet is needed.**

- **LB conduit fitting on the side of the house needs repair.**
- **Mini Split AC unit needs to be rewired correctly. Has exposed wires and also needs a disconnect.**

- **The outlet in the bottom floor bath should be changed to a GFI outlet.**
- **Missing plate on switch above panel box.**
- **Bottom floor bathroom outlet should be GFI outlet.**

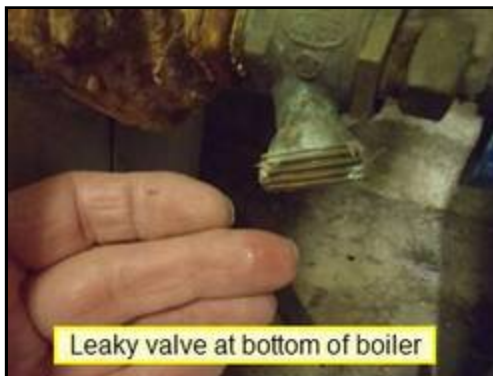
7.0 Picture 1

**7.0** The heating equipment is old. Remaining life expectancy cannot be determined. There are 3 heating zone valves and 2 were not operating at the time of inspection, the top main floor and the bottom front room. There is also a leaky valve at the bottom of the boiler and the gauge has a broken glass. I could not tell if the pressure or temperature was correct in the boiler. The gauge may not be reading correctly. A qualified Heating Company is suggested for a professional opinion on replacing the unit or repairing the present defects, since the unit is so old.

The wiring for the bottom floor thermostat had also been disconnected.

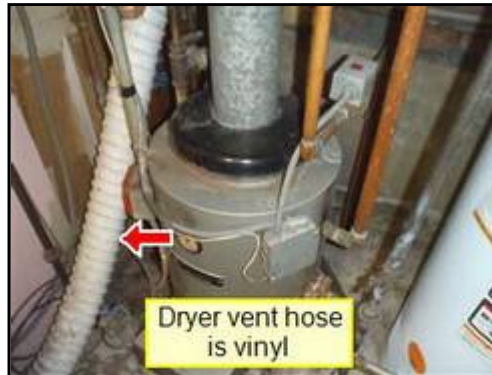
8.3 Picture 1

**8.3** The dryer is vented with a vinyl venting hose. Metal or flexible metal is recommended for safety.

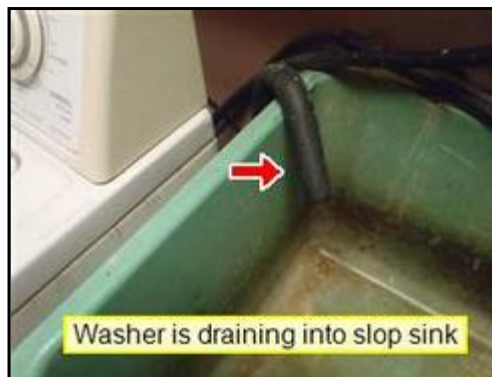
9.1 Picture 1

9.1 The washer is draining into the slop sink. This is okay providing the slop sink is in working order. At the time of inspection, the slop sink could not be used for this purpose. The plumbing trap has a leak and needs to be repaired..

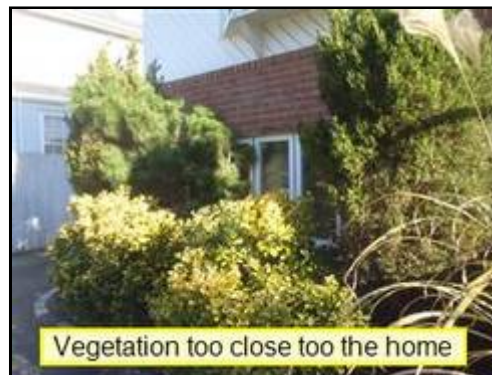
1.5 Picture 1

There is some vegetation close to the home. Vegetation too close to the structure can invite moisture and insects into the home. Removal or trimming is recommended.

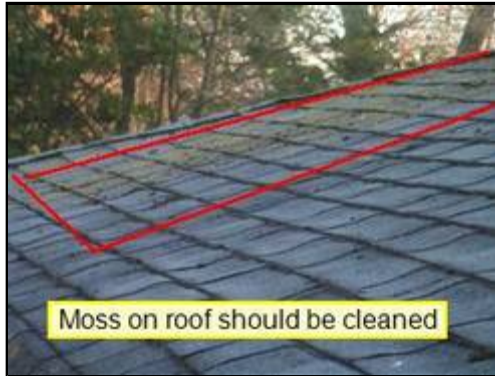
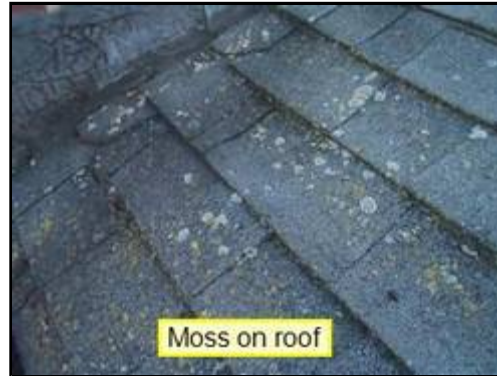
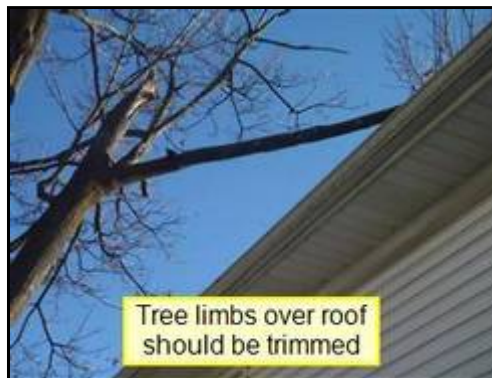
The rear roof has some moss. Moss holds moisture and can shorten the life expectancy of the shingles. Removal is recommended. Tree limbs hanging over roof should be trimmed.

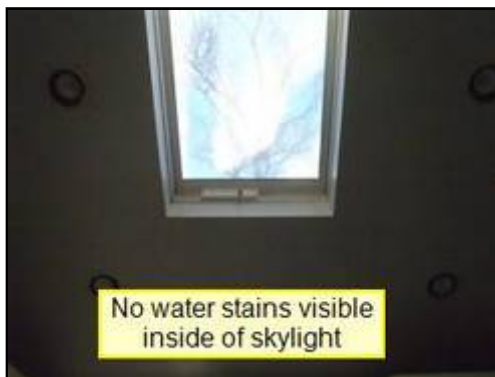
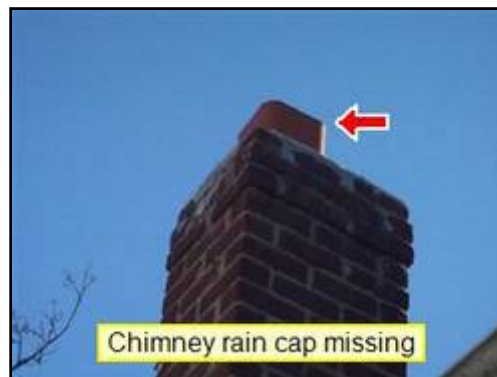
2.2 Picture 1

There is one skylight present. Skylights have been known to leak, but I have found no evidence of this at the time of inspection.

A chimney rain cap/spark arrestor is missing and is recommended for the chimney flu.

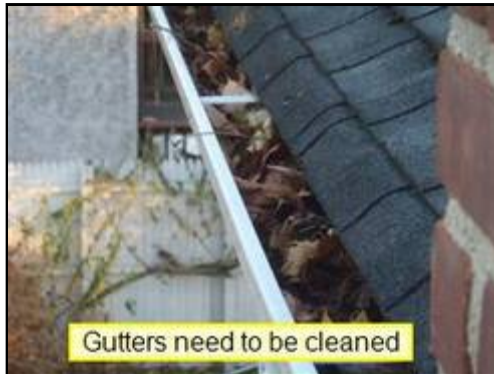
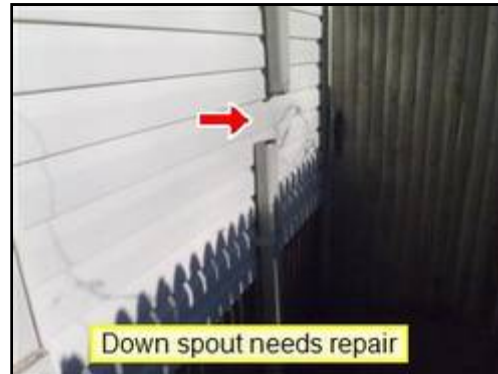
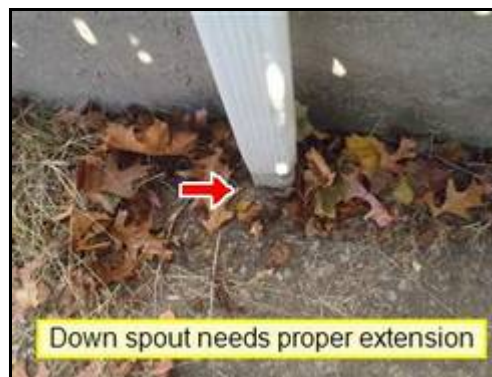
The gutters appear intact but, I am unable to determine if gutters leaks at seams or spills water. The gutters are full of debris in areas and needs to be cleaned. The debris in gutters can also conceal rust, deterioration or leaks that are not visible until cleaned, and I am unable to determine if such conditions exist. The downspout needs a repair and an extension or buried drain line to carry water away from the home .

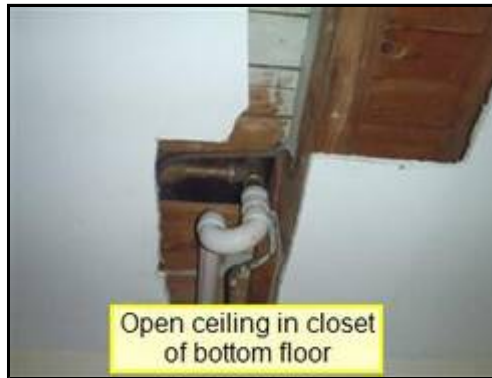
3.0 Picture 1

Closet ceiling on bottom floor has a large opening and needs repairs.

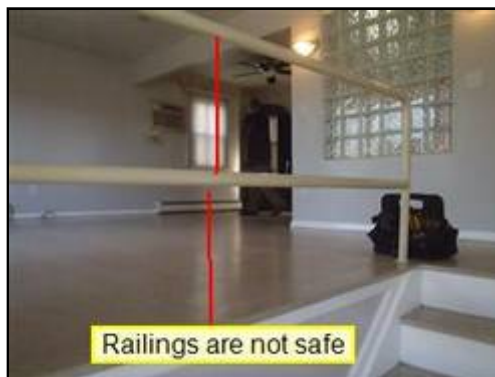
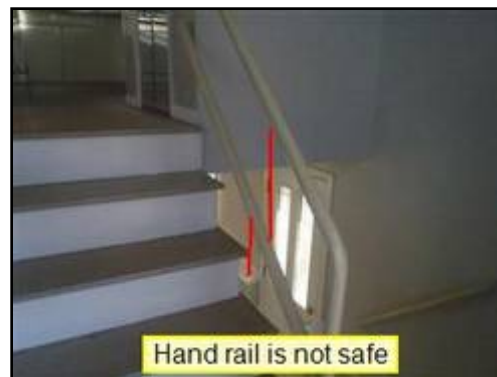
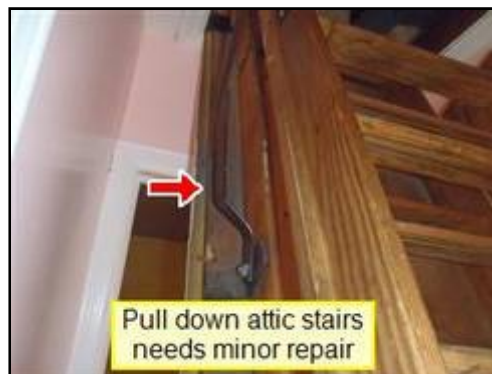
The interior railings have large openings and are climbable. A small child or pet can easily fall through and injury could occur. Proper railings with balusters not spaced more than 4" apart are required for safety.

The pull down stairs to the attic is difficult closing. The side hinge needs repair.

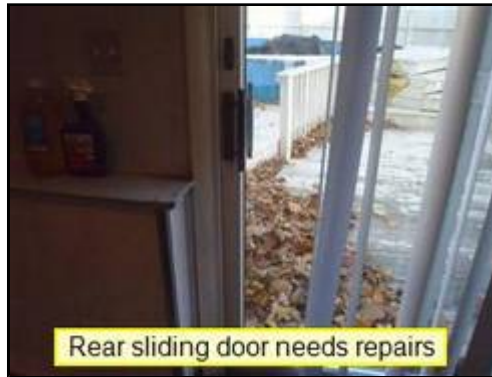
3.5 Picture 1

The rear sliding insulated door is very difficult to open and close. Repairs are needed.

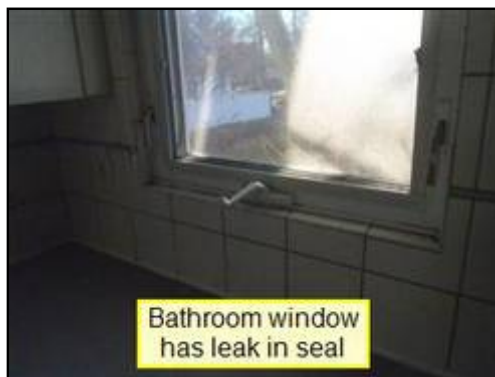
3.6 Picture 1

There are 3 windows with leaks in the seals and replacement or repairs are needed.

The window crank is broken for the front bay window.

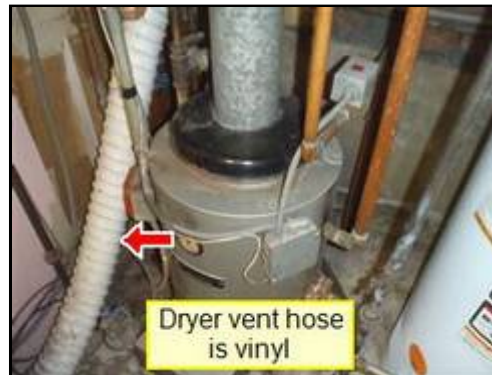
8.3 Picture 1

The dryer is vented with a vinyl venting hose. Metal or flexible metal is recommended for safety.

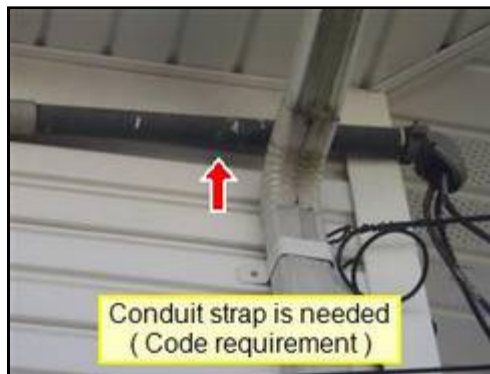
6.0 Picture 1

Conduit for electrical service entrance cable is not secured properly and only one strap is holding the conduit to the structure. More straps are required to be secured properly.

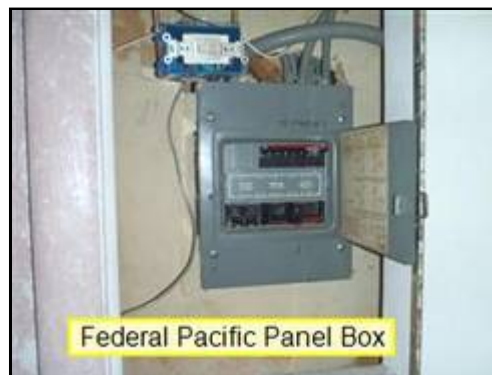
You have a Federal Pacific panel which was legal at the time of inspection, but there is a possibility that the circuit breakers may not trip when shorted or over loaded, possibly causing an electrical hazard. Federal Pacific did not comply with UL requirements in 1980 and shortly after, Federal Pacific company went out of business. For further information you can check any website under the listing of Federal Pacific. Replacement is a necessity.

6.2 Picture 1 Federal Pacific panel boxes are

I recommend you consult a licensed electrical contractor for the replacement.

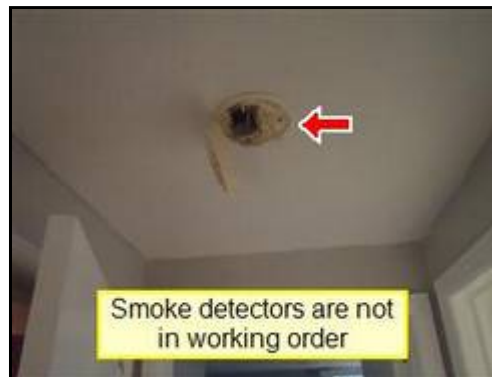
6.4 Picture 1

There are smoke detectors located in the home and did not work when tested. At least one smoke detector on each floor is necessary, installed to the manufacturer's specifications. Today's electrical codes require one smoke detector in each bedroom and one just outside the bedroom area, in the hallway.

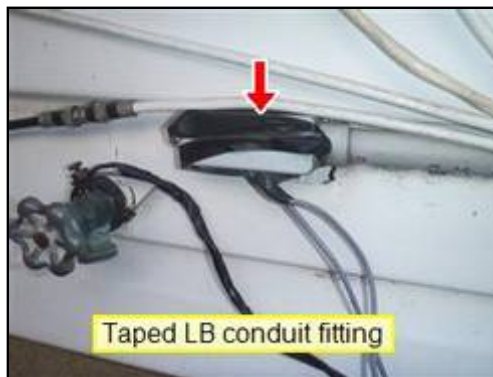
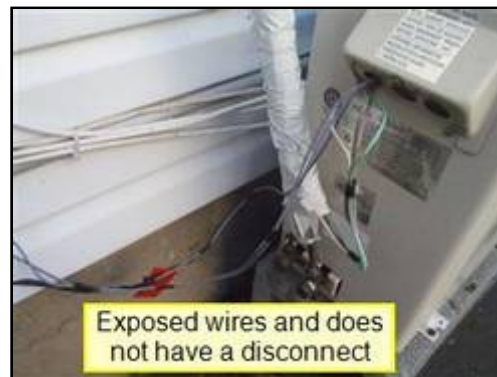
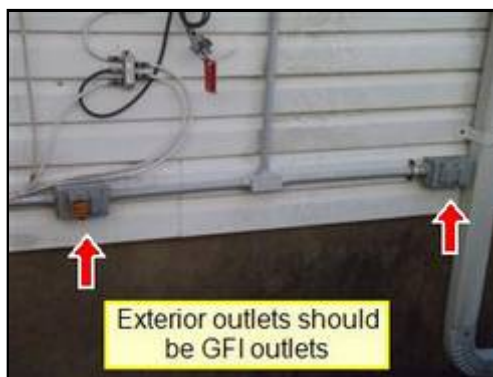
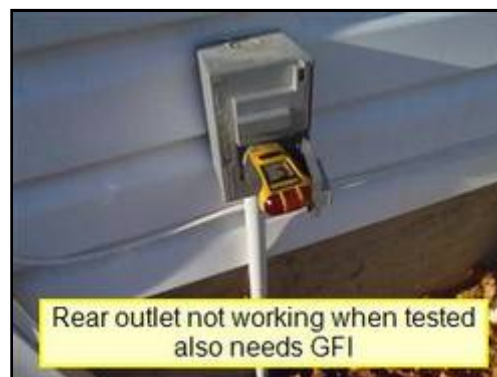
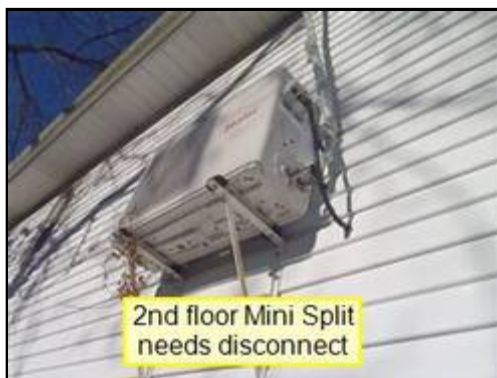
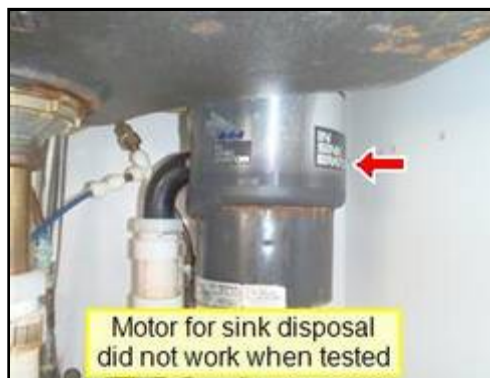
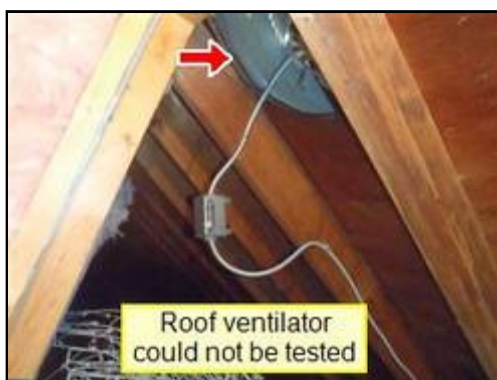
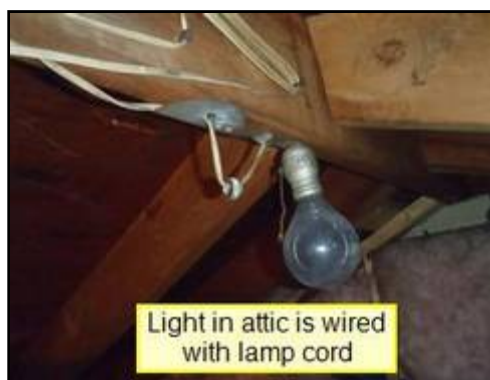
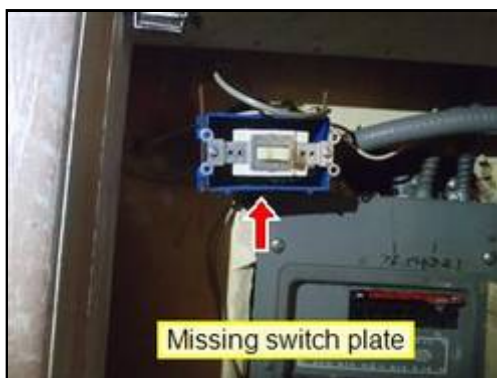
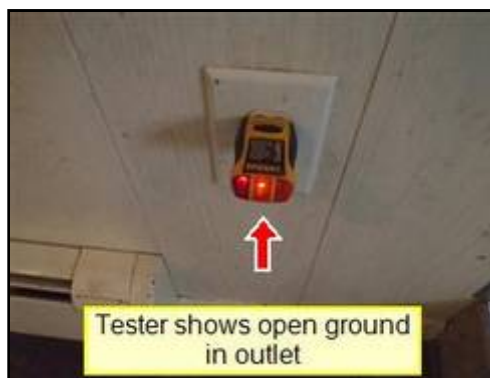
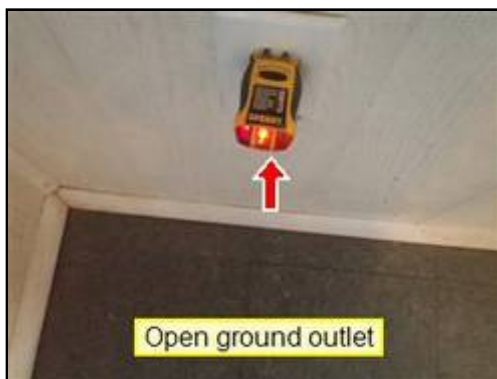
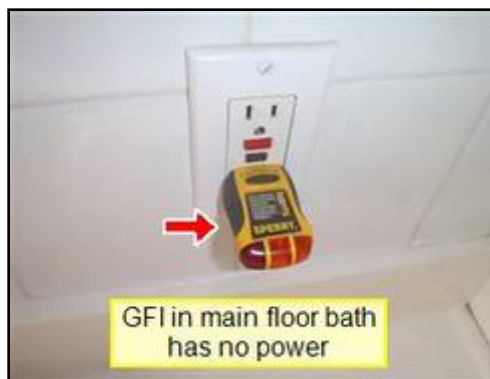
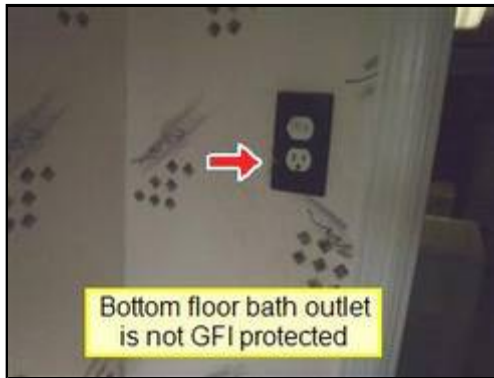
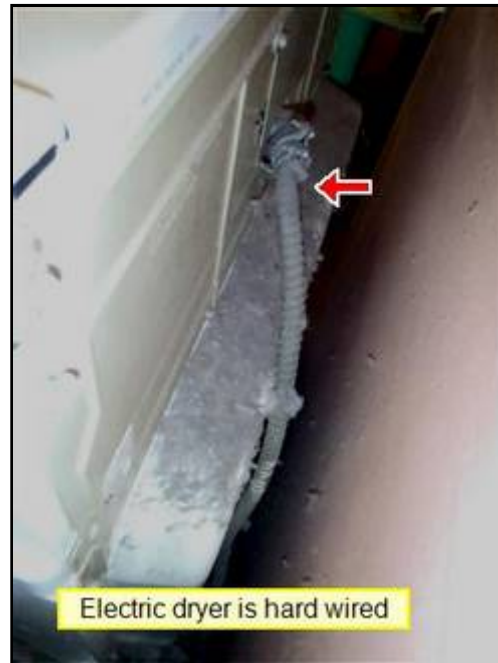
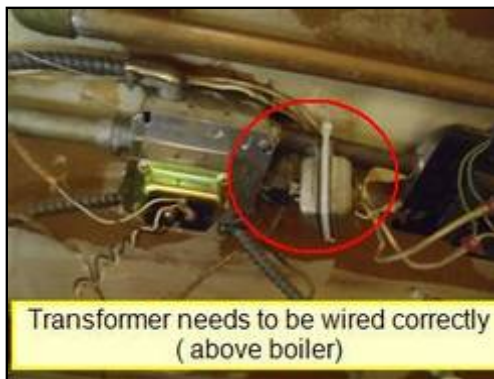
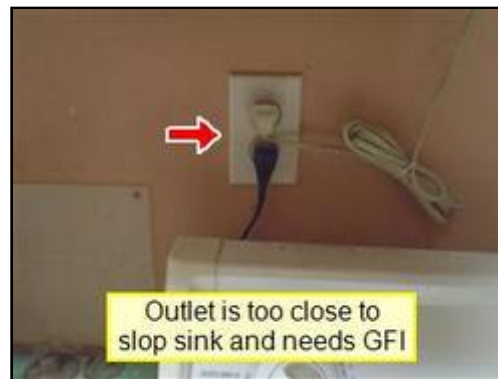
- **Recommend all exterior outlets be changed to GFI outlets.**
- **Rear exterior outlet does not have proper wiring, Hot is reversed and no neutral present. GFI outlet is needed.**
- **LB conduit fitting on the side of the house needs repair.**
- **Mini Split AC unit needs to be rewired correctly. Has exposed wires and also needs a disconnect.**
- **2nd floor AC mini split unit should have a disconnect.**
- **Sink disposal did not work when tested.**

- **Roof ventilator could not be tested because of temperature. These fans are thermostatically controlled.**
- **Light in attic is wired with lamp cord and needs to be disconnected or rewired.**
- **The GFI outlet in the main floor bathroom tested with no power.**
- **The outlet in the bottom floor bath should be changed to a GFI outlet.**
- **Missing plate on switch above panel box.**
- **Bottom floor bathroom outlet should be GFI outlet.**
- **Rear lower room has open ground outlets.**
- **The clothes dryer is electric and is hard wired. A disconnect is required by code if the electric panel box is not within site of the dryer.**
- **Transformer above boiler is not wired correctly.**
- **Outlet next to slop sink should be GFI.**

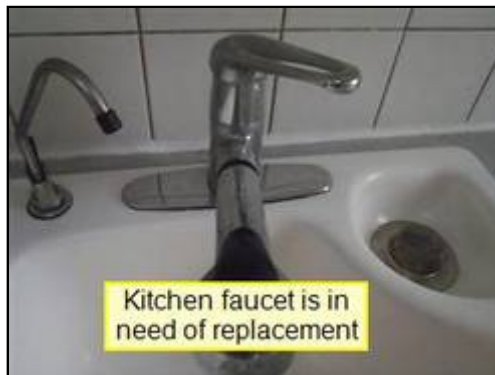
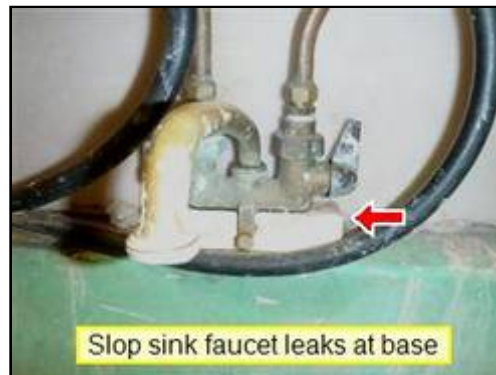
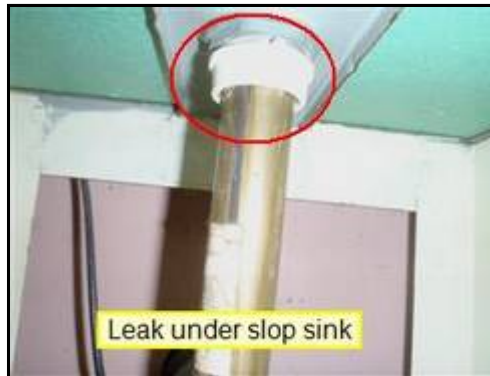
- The sink faucet in the kitchen does not stay opened when operated. New faucet is needed.
- The slop sink leaks at the base and there is also a leak in the plumbing trap. This must be repaired because the washer drains into the slop sink. A qualified plumber is recommended.

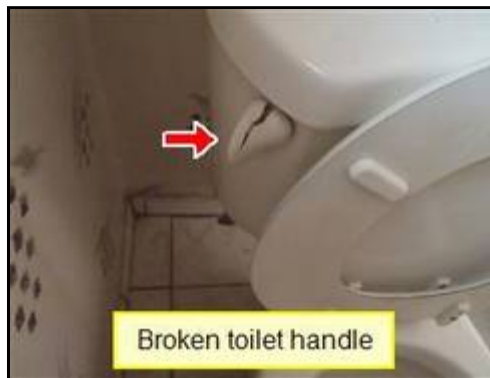
5.1 Picture 1

The bottom floor toilet has a broken handle and keeps running when flushed.

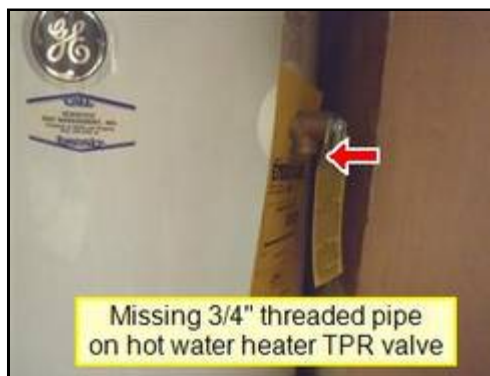
5.2 Picture 1

According to the ANS on the Hot Water Heater, it was manufactured in 2012. Most Hot Water Heaters have an average life expectancy of 15 -20 years.

The T&P (Test and Pressure) valve on water heater needs a 3/4" threaded pipe to extend within 6 inches of floor for safety. (PVC is not approved for hot water use). I recommend repair by a qualified person.

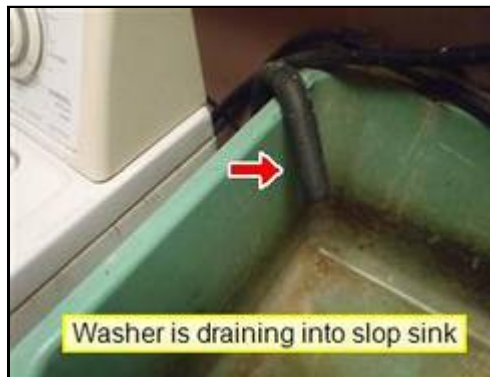
9.1 Picture 1

The washer is draining into the slop sink. This is okay providing the slop sink is in working order. At the time of inspection, the slop sink could not be used for this purpose. The plumbing trap has a leak and needs to be repaired..

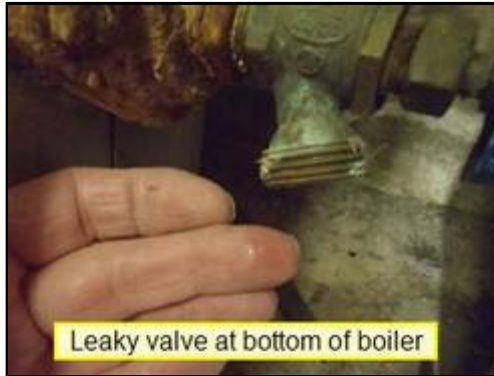
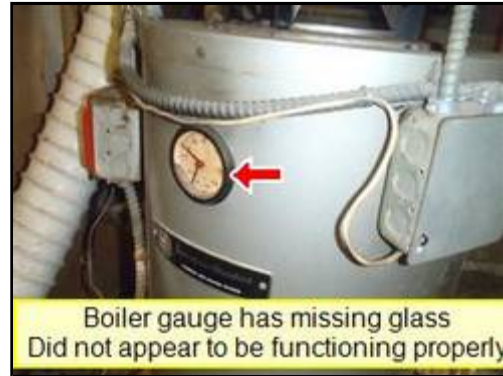
The heating equipment is old. Remaining life expectancy cannot be determined. There are 3 heating zone valves and 2 were not operating at the time of inspection, the top main floor and the bottom front room. There is also a leaky valve at the bottom of the boiler and the gauge has a broken glass. I could not tell if the pressure or temperature was correct in the boiler. The gauge may not be reading correctly. A qualified Heating Company is suggested for a professional opinion on replacing the unit or repairing the present defects, since the unit is so old.
