# Inspection Report

1335 Pulaski Rd.  
East Northport NY

**North Shore Home Inspection Service**

<b>Date:</b> 8/6/2012	<b>Time:</b> 10:00 AM	<b>Report ID:</b> 1221
<b>Property:</b> 1335 Pulaski Rd. East Northport NY	<b>Customer:</b> Meagan Walsh	<b>Real Estate Professional:</b> Lisa Collet

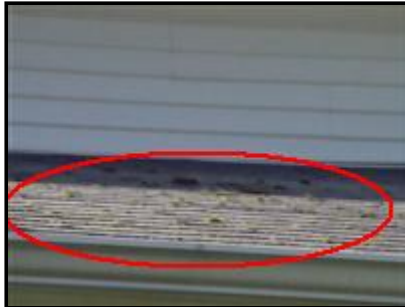
According to the Real Estate Agent, the roof covering is 10 years old. The rear,(north side) has some existing moss growing. Moss holds moisture and can shorten the life expectancy of the roof covering.I recommend a professional roof specialist for a thorough cleaning of the moss.Some companies are also knowledgable in removing stains.

1.0 Picture 1 Moss growing on rear roof shingles

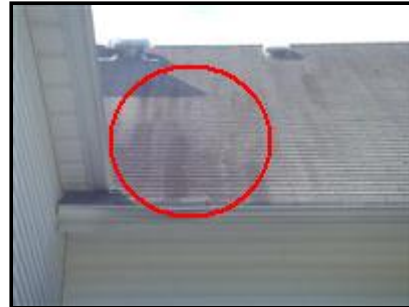
1.0 Picture 2 Rear roof stains,which can be professionally removed

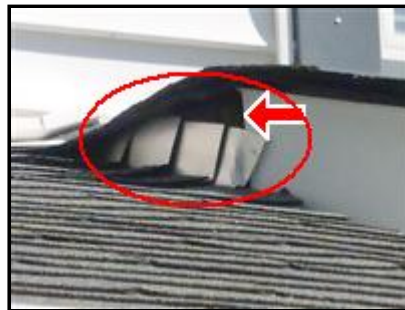
There is one area in the front that does not appear to have proper flashing or trim.I Recommend a professional contractor for repairs.

1.1 Picture 1 Front part of roof fascia needs proper flashing repair

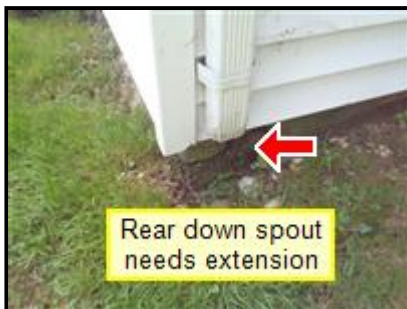
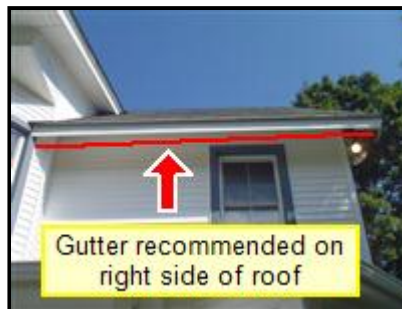
The gutters appear intact but due to the lack of rain at the time of inspection, I am unable to determine if gutters leak at seams or spills water. There is no gutter on the top right side of the roof. A gutter is recommended.

The rear down spout needs an extension to drain water away from the home.

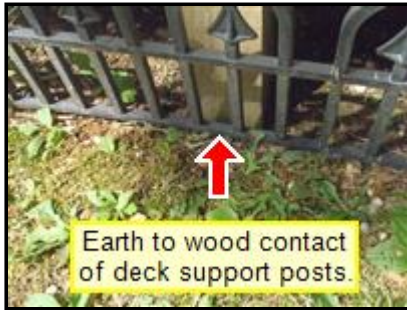
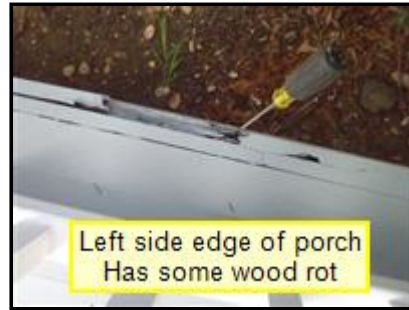
- Although there appears to be proper concrete footings for the deck support posts, there is wood to earth contact. Wood to earth contact can eventually rot the support posts. Removal of soil from the base of the support posts is recommended.

The left side of the front porch has some wood rot. Minor repair is recommended.

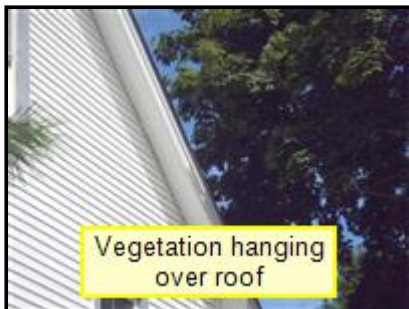
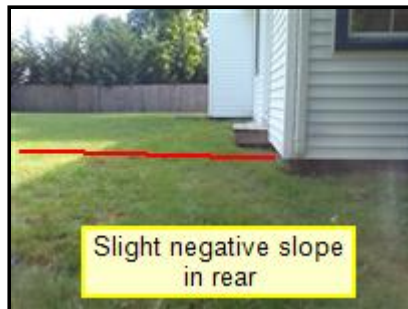
There is a negative slope at the rear of home and can cause or contribute to water intrusion or deterioration. I recommend correcting landscape to drain water away from home.

. The driveway has many normal settling cracks, Remaining life expectancy cannot be determined.

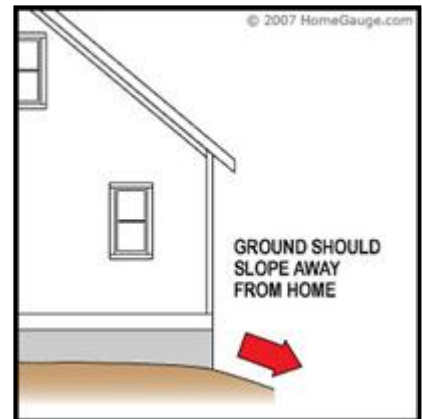
2.4 Picture 3 Ground should slope away from home, 1" per foot for at least 6 feet

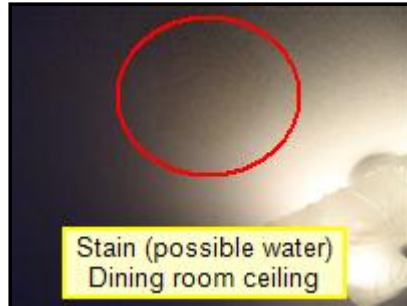
4.0 Picture 1

- There is one stain on the dining room ceiling which I could not identify the source or cause. Monitoring is suggested.

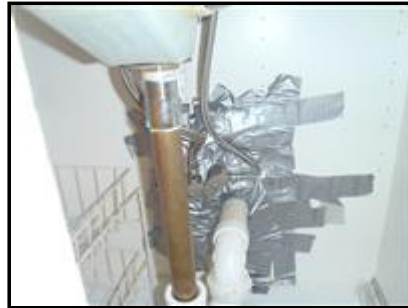
- The 2nd floor bath has a large hole under the sink and should have a professional repair.

4.1 Picture 1 Large hole under sink vanity with duct tape

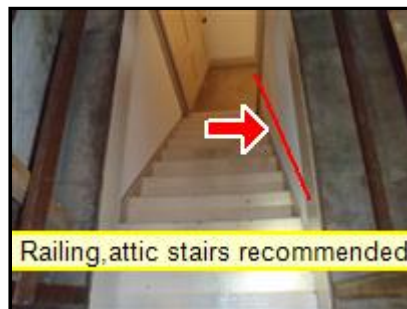
4.3 Picture 1

- Stairs to the attic is missing a hand rail. A hand rail installation is recommended. This is considered a safety hazard.

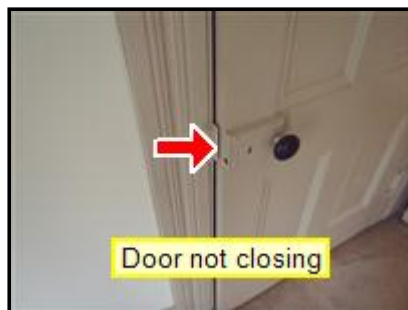
4.5 Picture 1

- There is one closet door on the second floor that is not closing properly and needs adjustment.

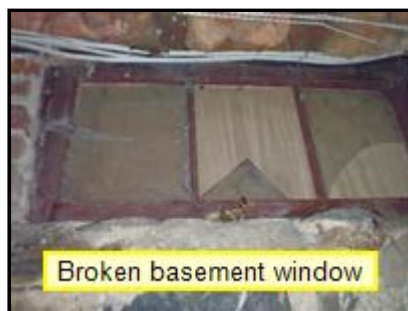
4.6 Picture 1

- One basement window is broken and is boarded up. Repairs recommended.

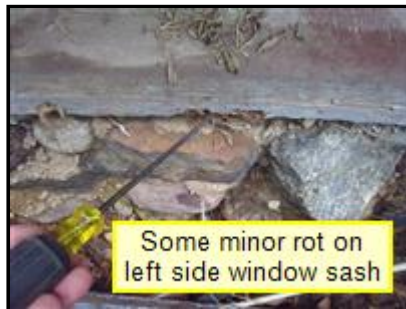
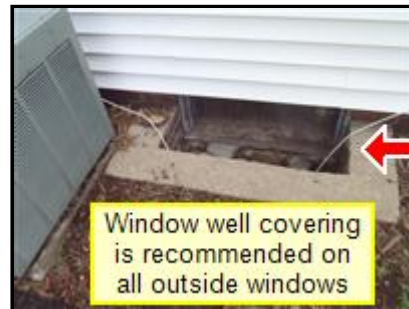
**5.0** The basement foundation consists of stone and there is some dampness and possible minor water intrusion. Proper outside grading, covering of window wells, and the installation of down spout extensions is recommended.

The left basement window wood sash is slightly rotted. Repair is recommended.

The crawl space floor is all dirt which contributes to moisture. Sometimes plastic vapor barriers are installed over the dirt to help prevent the natural build up of moisture. I recommend consulting with a professional water proofing company for advice and possible installation of a vapor barrier in the crawl space. This is not a necessity, but is highly recommended. There also should be some venting, and I did not notice any outside vents for the crawl space.

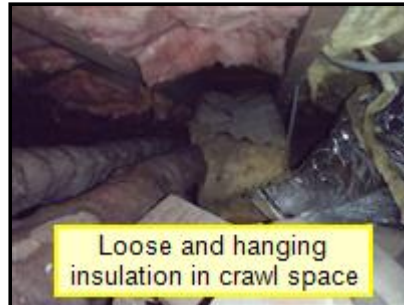
9.1 Picture 1

Some insulation is hanging in the crawl space and should be re installed.

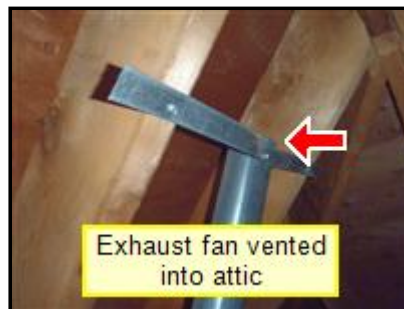
9.4 Picture 1

The 2nd floor bath exhaust fan is vented into the attic. Bath exhaust fans should be vented to the outside. Proper venting is recommended.

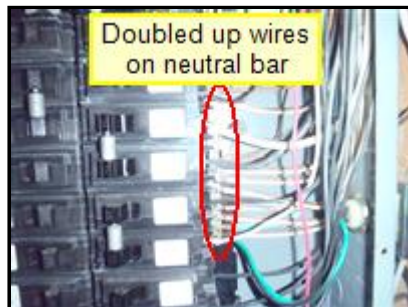
7.1 Picture 1

- ⚡ There are some doubled up wires on the neutral bus bar in the main panel. Although this is not to code, if the same gauge wires are doubled up under the same lug, I do not feel this is a hazard, even though it is not to code. Recommend an evaluation by a licensed electrician.

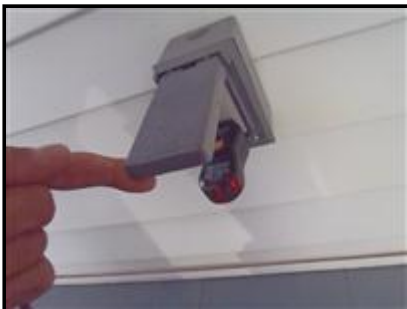
- The front porch GFI outlet did not trip when tested.
- Loose outlet in one room.
- Open wires should be in junction boxes or be removed.(Basement)
- Missing smoke detector in basement.
- Panel box, All circuits should be labeled.
- Loose round box in basement.

7.4 Picture 1 Front porch GFI was on but did not trip when tested

The following items should be evaluated or repaired by a qualified licensed electrician:

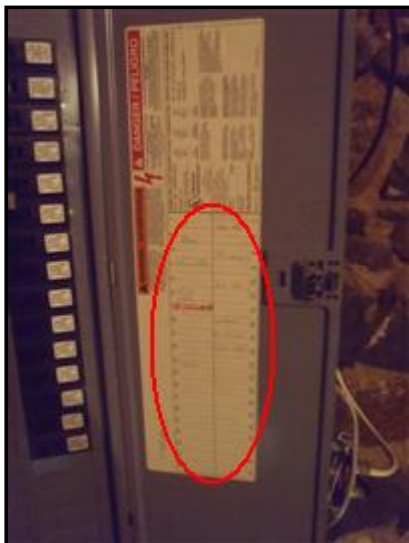
7.4 Picture 7 Not all circuits are labeled

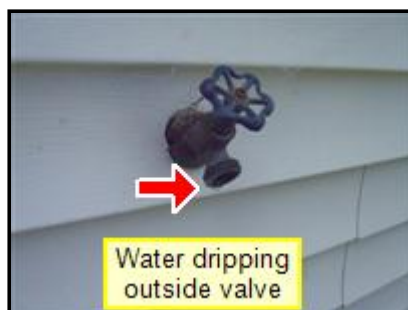
6.1 Picture 1

The rear outside water valve is leaking. Recommend a qualified plumber for repairs.

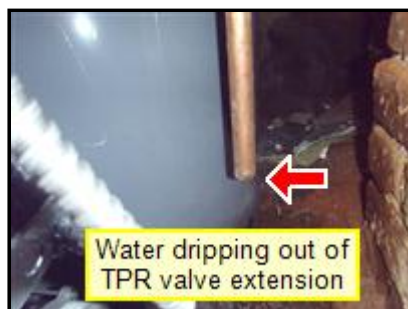
6.2 Picture 1

The TPR valve on the hot water heater is pushing out water and should be checked by a qualified plumber.

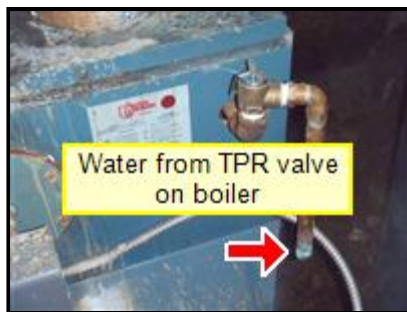
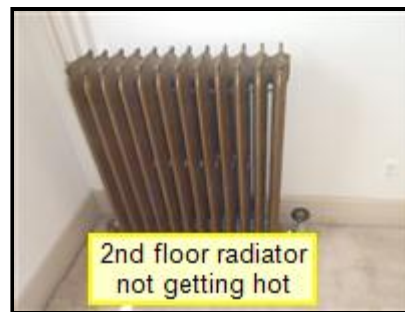
When the boiler was shut off by the emergency switch, the TPR valve let go, pushing out water and the temperature gage was reading 190 degrees. I recommend a qualified heating contractor for repairs.

One of the radiators on the 2nd floor did not seem to get hot when testing the heating system. The valve could possibly be turned off. Recommend heating or plumbing contractor for an evaluation.

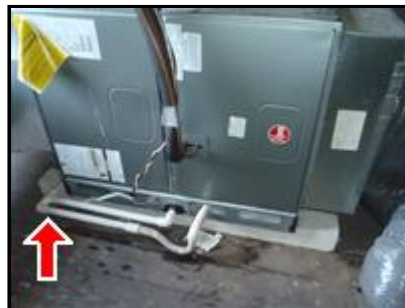
The condensate lines for the air handler are teed together and is leaking. The condensate lines can be teed together as long as there is a float switch in the drain pan. I did not notice a float switch. Correction is needed.

8.5 Picture 1 Condensate lines are teed together and is leaking
